## Innendørsklima i historiske bygninger i museene i Rogaland

*- Kan man spare strøm og samtidig bevare bygninger og deres gjenstander?*

**Stina Ekelund Erlandsen**

**Museumstjenestene**  
i Rogaland

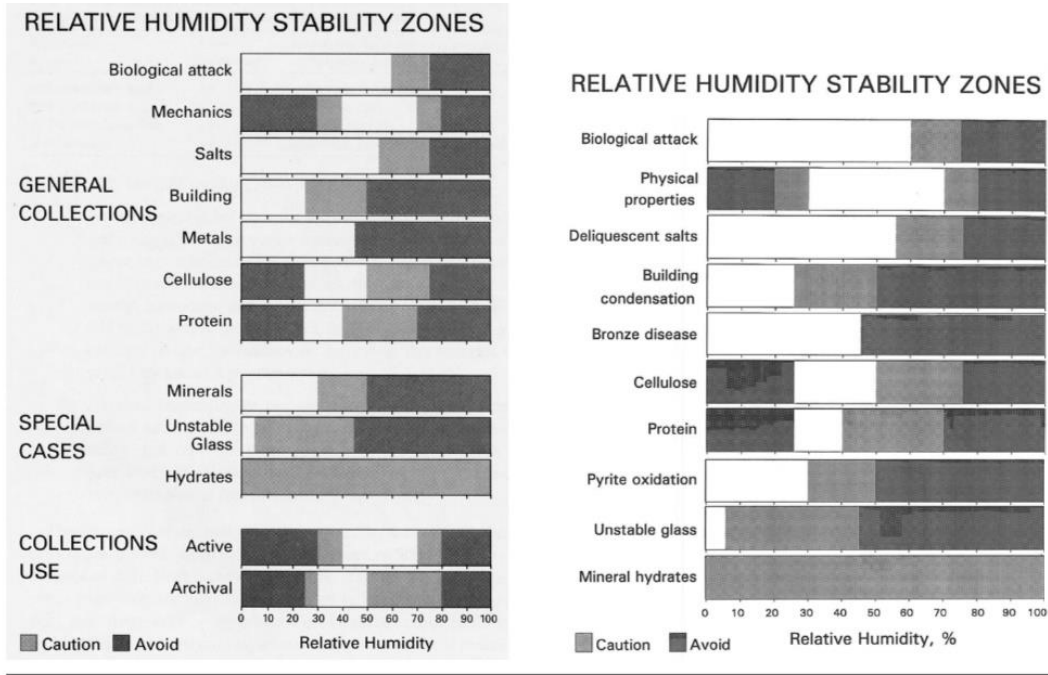
FIGURE 6. Relative humidity stability zones from (left) Erhardt and Mecklenburg (1994:37) and (right) Erhardt et al. (1995:20). The ranges of relative humidity are suggested for various materials and situations. According to Erhardt and Mecklenburg (1994), “no one RH is ideal, and any value chosen must be a compromise.”

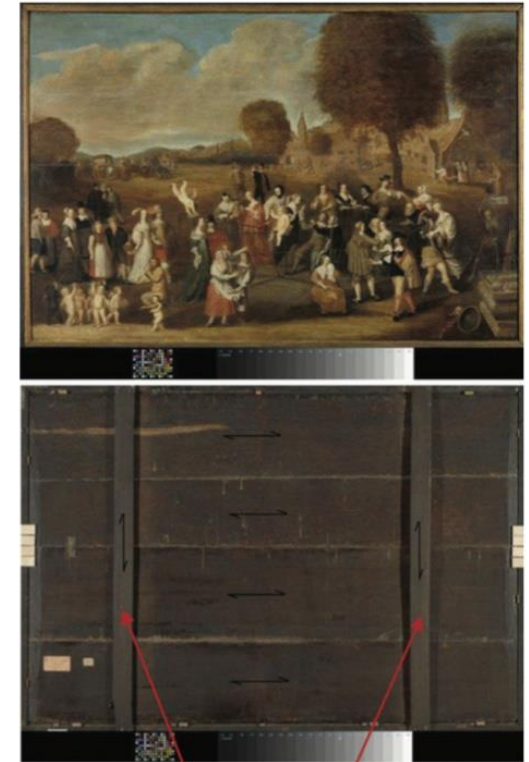
**Restraining cross battens**

**FIGURE 4.** Four-board panel with original cross battens and characteristic glue joint failure, later rejoined. Hendrik Noorderwiel, Rijksmuseum SK-C-1550, 1,177 × 1,770 × 10 mm, 1647. Top photo courtesy of Rijksmuseum; bottom photo by Stina Ekelund.

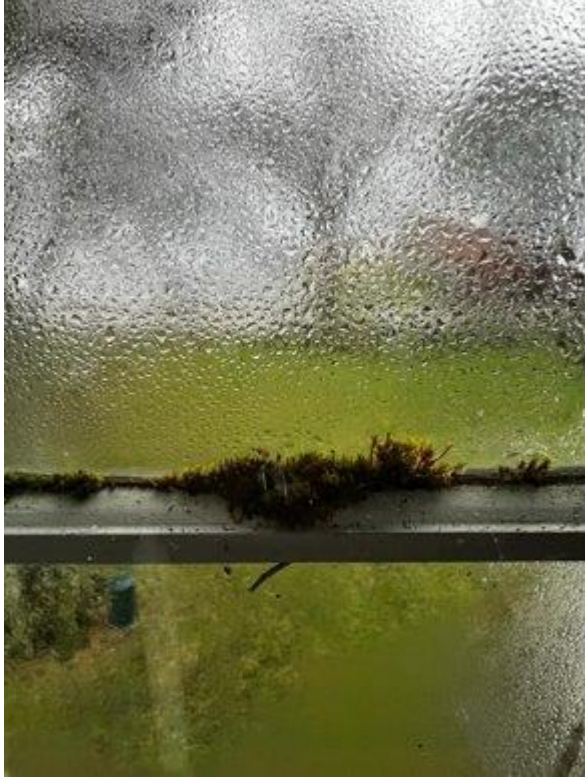
# Erfaring fra interiørprosjektet

Bygninger med begrenset eller ingen oppvarming

- Begrense vegetasjon og vann rundt (og i) bygningene
- Korrosjon av metall. Få nye «klimarelaterte» skader
- Gode rutiner
- Sirkulasjon
- Mugg
- Kondens
